REPORT ON THE FOLLOW-UP OF THE DIABLO MUDO EXPLORATION PROJECT

NEVADO N° 1 and NEVADO N° 2

November 2011

Huaraz – Peru

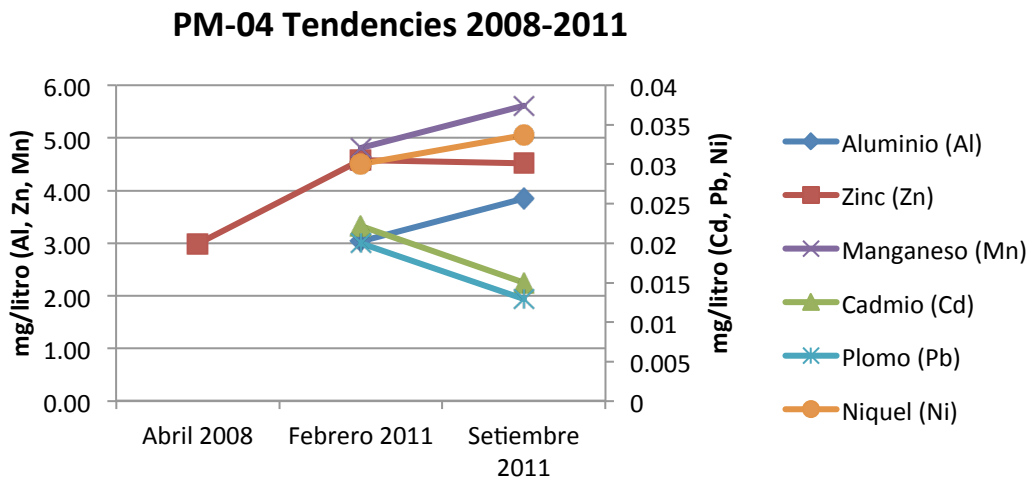
In the first graph that follows it is possible to observe the tendencies over time for the monitoring station PM-04. First, for aluminum, nickel, manganese and zinc the concentrations are rising over time. Second, the concentrations for cadmium and lead are going down over time.

THERE IS NO WAY TO MAKE A CONCRETE CONCLUSION ABOUT WHICH FACTORS PLAY THE PRINCIPAL ROLE IN THESE TENDENCIES OVER TIME. The most probable explanation is that the mining activity is a factor in the changes observed, but that contamination from natural sources such as the annual water cycles and the high concentrations of certain elements found in the environment also could be a factor. These results call attention to the need for a sustained monitoring effort to better understand these observations.

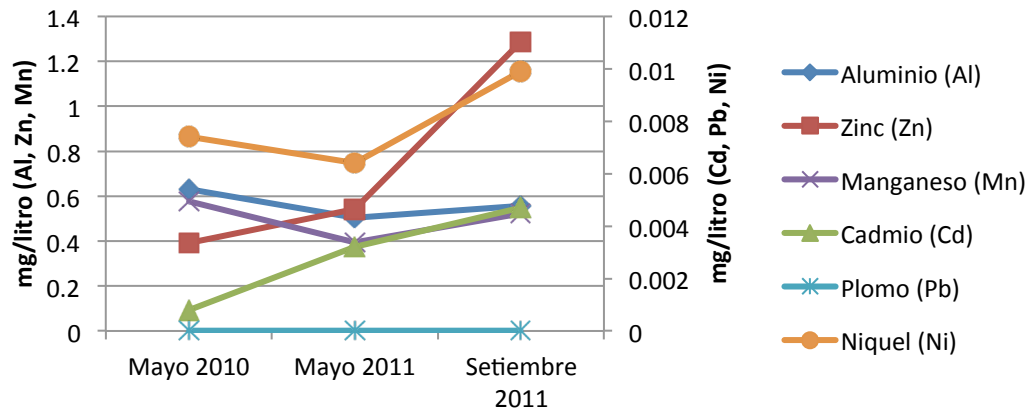
P2 Tendencias 2010-2011

In the second graph it is possible to observe the tendencies over time for the monitoring station P2. First, for zinc, nickel, and cadmium the concentrations are rising over time. Second, the concentrations of lead, aluminum, and manganese are either staying level or dropping over time.

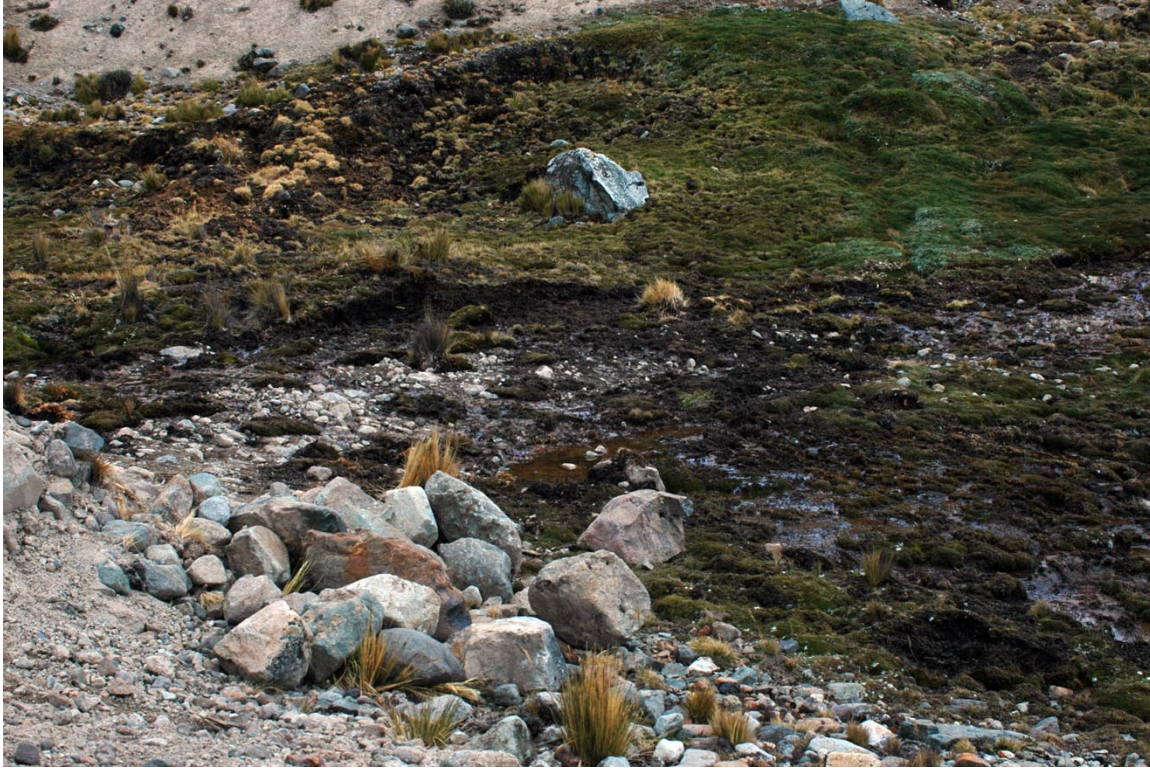
3. It was also observed that the installation has barrels for three kinds of solid wastes (ANNEX C - Photo 10).
4. The group then left the perforation site to take water samples. On the way back down the group found a wetland covered with a greasy substance which indicated the possible presence of diesel (ANNEX A Locator Map y ANNEX C Photos 1-5). According the senses of smell and taste the water in the wetland was contaminated with diesel, but because the work group had not anticipated this observation, no one had a bottle to take a sample; hence there are no laboratory results to confirm the presence of diesel at this location. Nevertheless, in the opinion of Timothy Norris, Mr. Oswaldo Gonzales (SERNANP), and Mr. Lindolfo Esteban Mendoza (Pacllon) the substance was diesel. According to the two environmental engineers from the mine, the substance was most likely to be a secretion or other biological product from some plant in the area.

At the site of the un-confirmed diesel spill a greasy substance was observed that smelled and tasted like diesel.

PHOTO 1: The site of the possible spill– see ANNEX A – LOCATOR MAP

The competent state authority should take action as necessary. The company Minería Raura S.A., responsible for the activities at Diablo Mudo, should restore the wetland at this site.

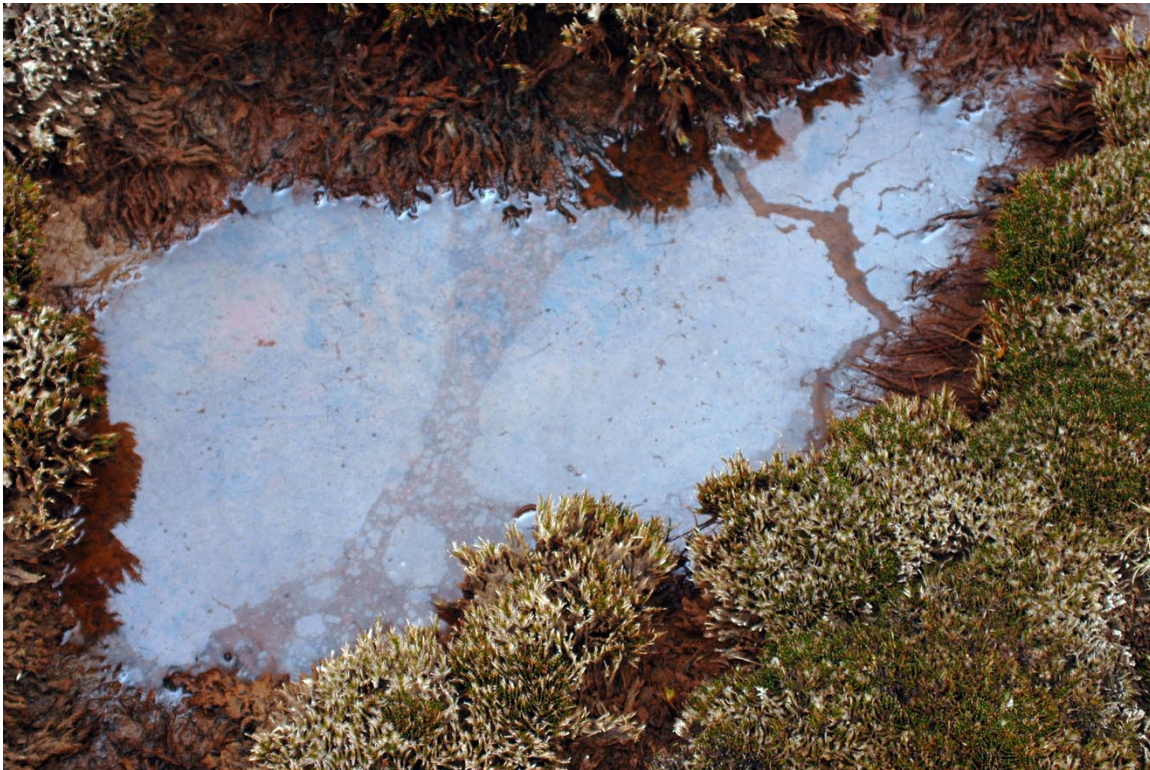
PHOTO 2: Evidence of the greasy substance at the possible spill site

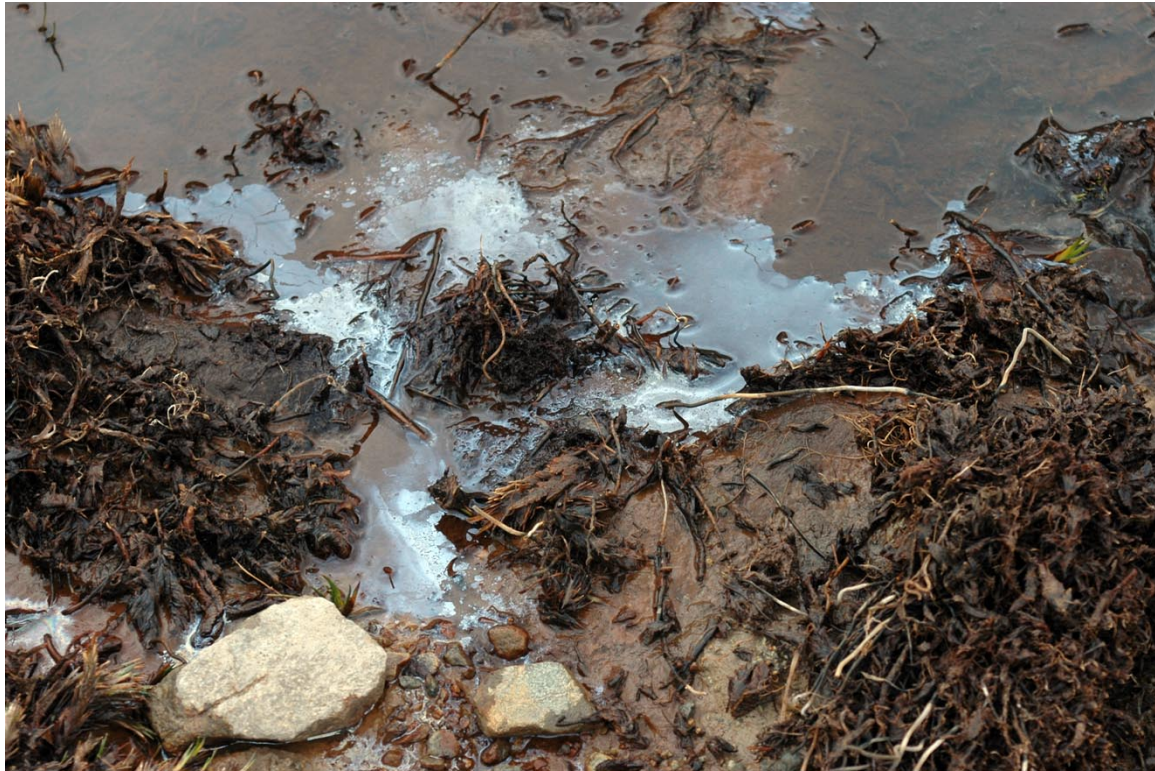
PHOTO 3: Evidence of the greasy substance at the possible spill site

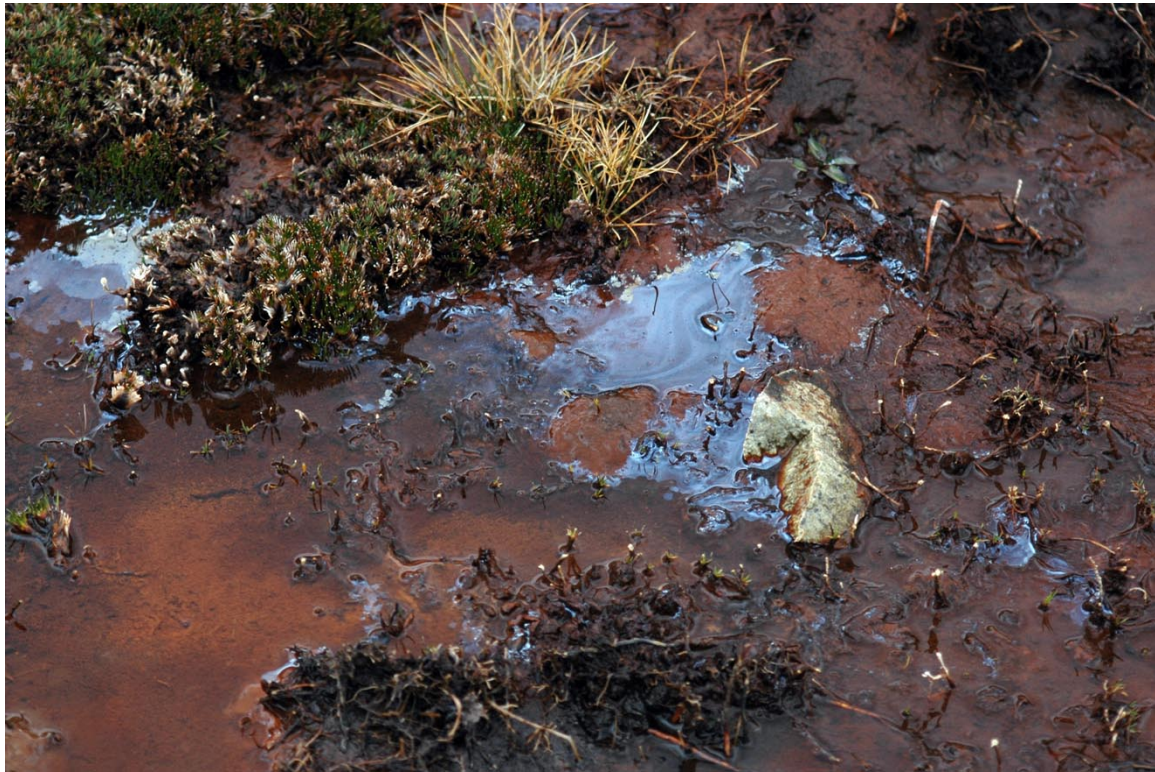
PHOTO 4: Evidence of the greasy substance at the possible spill site

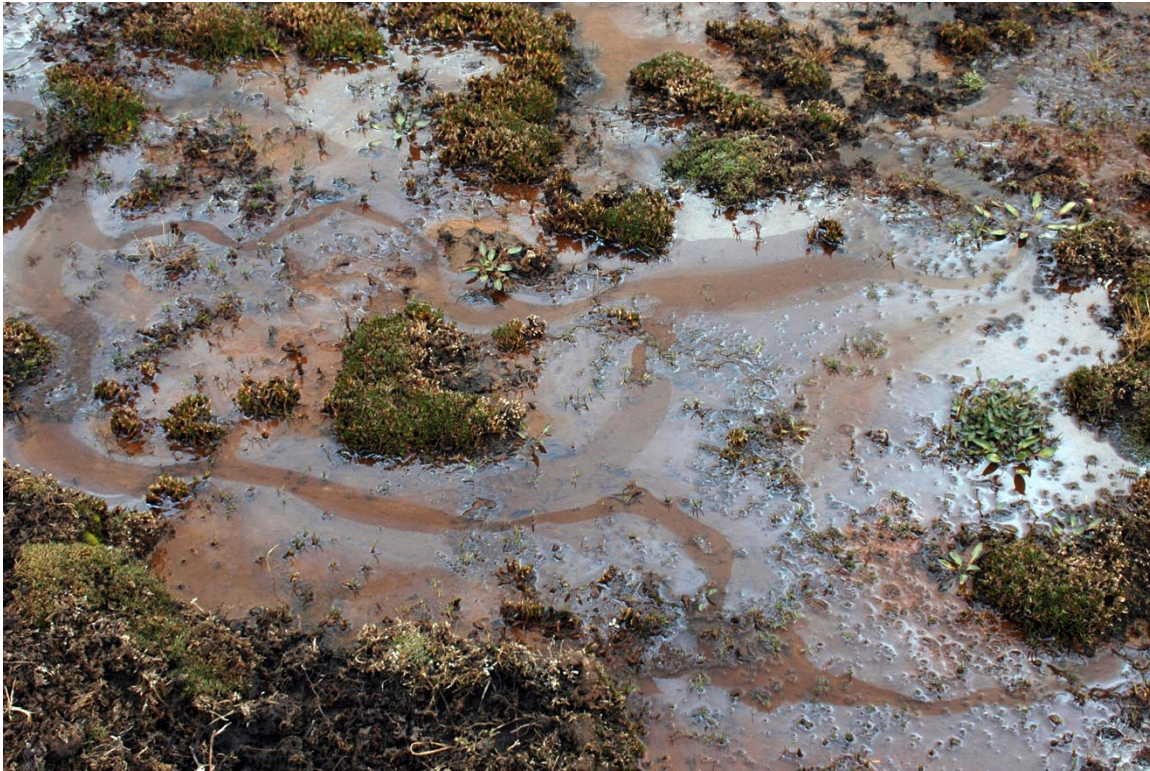
PHOTO 5: Evidence of the greasy substance at the possible spill site

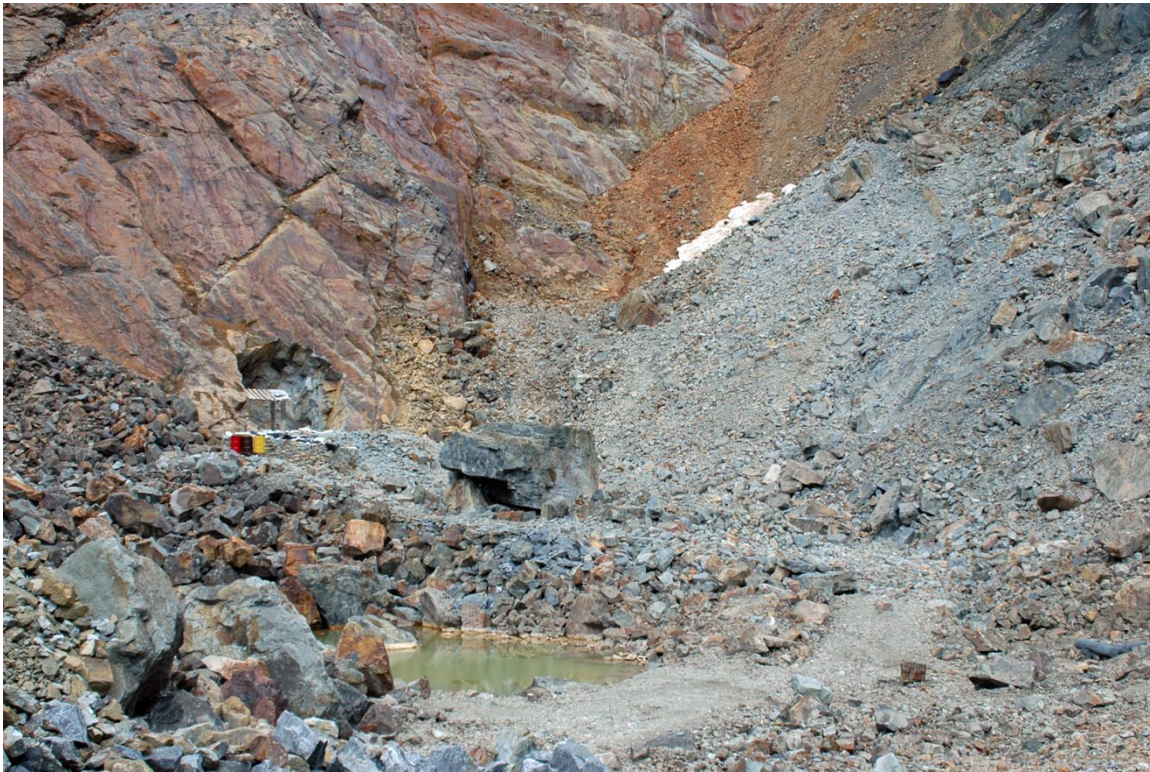
1. The work group left Pacllon and walked up Achin watershed, and then up the Ochsapata watershed, and finally up the Qashpapama watershed on September 19th 2001 in order to arrive at the perforation site located at the coordinates UTM ZONE 18S EAST 282596 NORTH 8861985 (PSAD 56) (ANNEX A Locator Map and ANNEX C Photo 6). It was observed that the exploration activity was paralyzed.

PHOTO 6: The perforation site, observe the lack of activity (paralyzed)

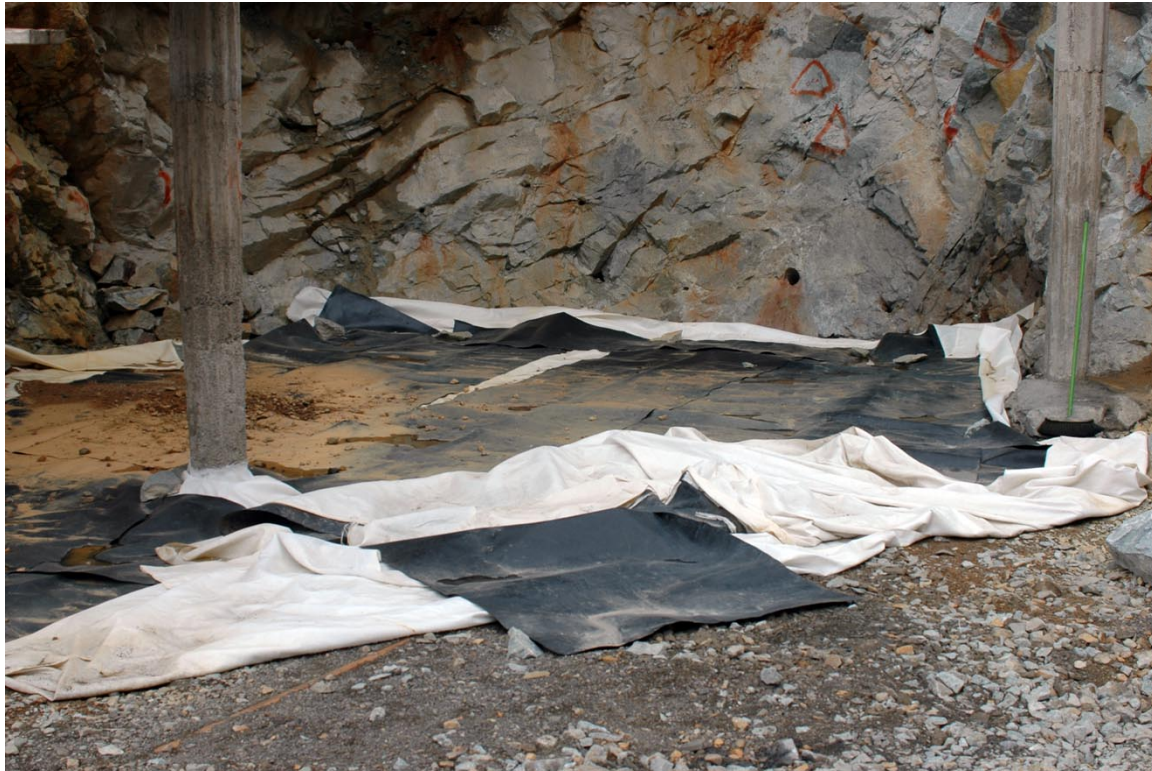
2. At the perforation site it was observed that the mud settling ponds now have impermeable membranes (ANNEX C Photo 7) much like the actual perforation site also has impermeable membranes (ANNEX C Photo 8). Apparently the recent installation of these membranes is due to the finding No3 from the report No 020-2011-SERNANP-DGANP-PNH "Seguimiento al Proyecto de Exploración Diablo Mudo Nevado N° 1 y Nevado N° 2." [the first follow-up report from earlier in the year]. Finally it was observed that the mud settling ponds were empty (ANNEX C Photo No 9) which begs the question: where is Minería Raura S.A. disposing of the mud and water?

PHOTO 7: The perforation site with impermeable membranes

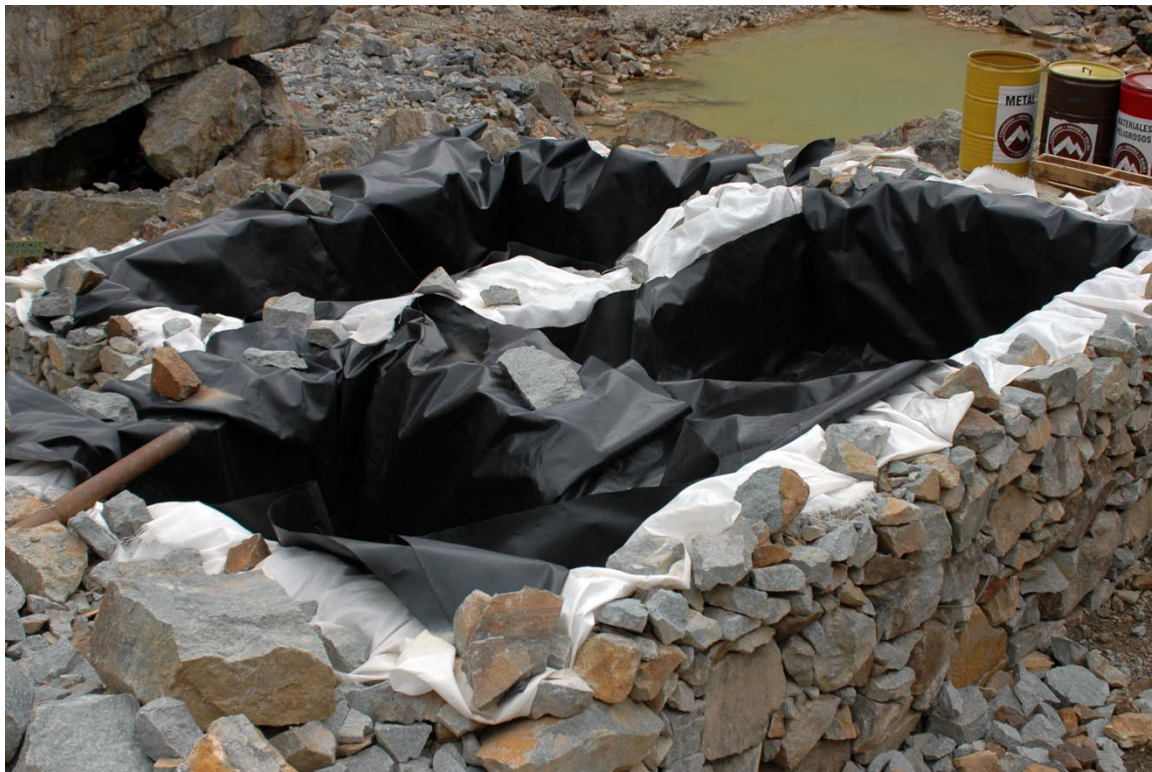
PHOTO 8: The mud settling ponds with impermeable membrane

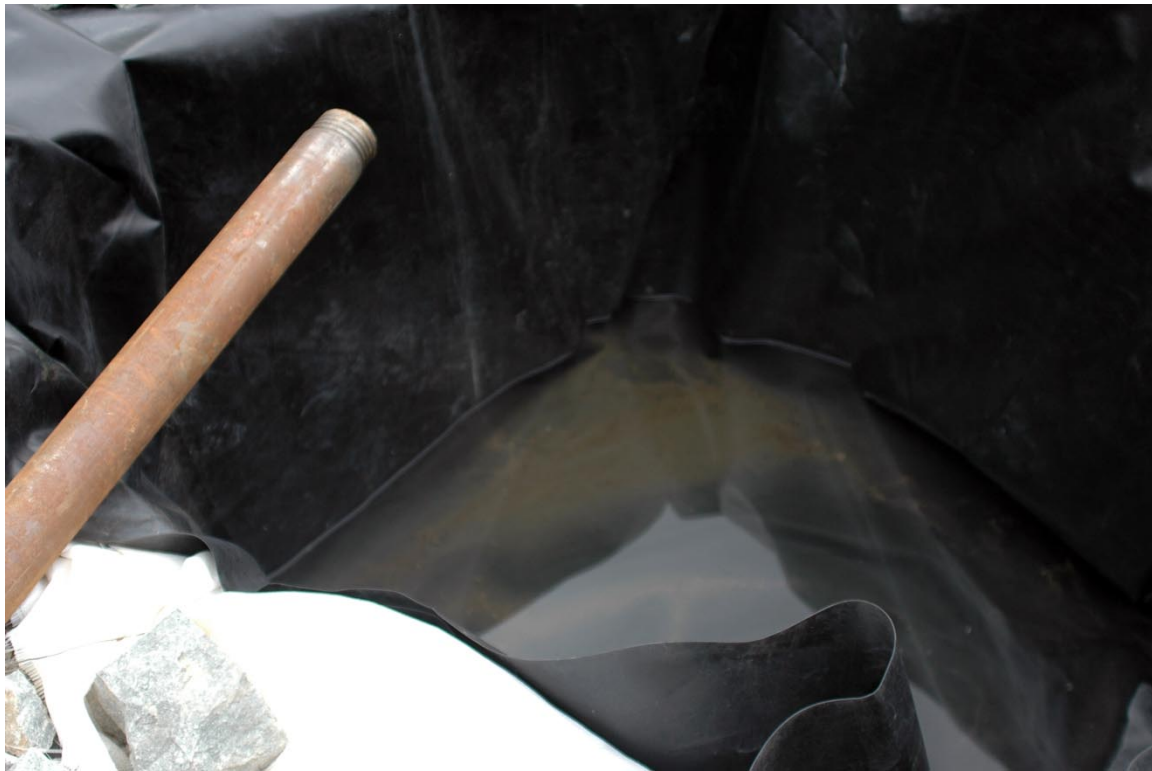
PHOTO 9: An empty mud settling pond

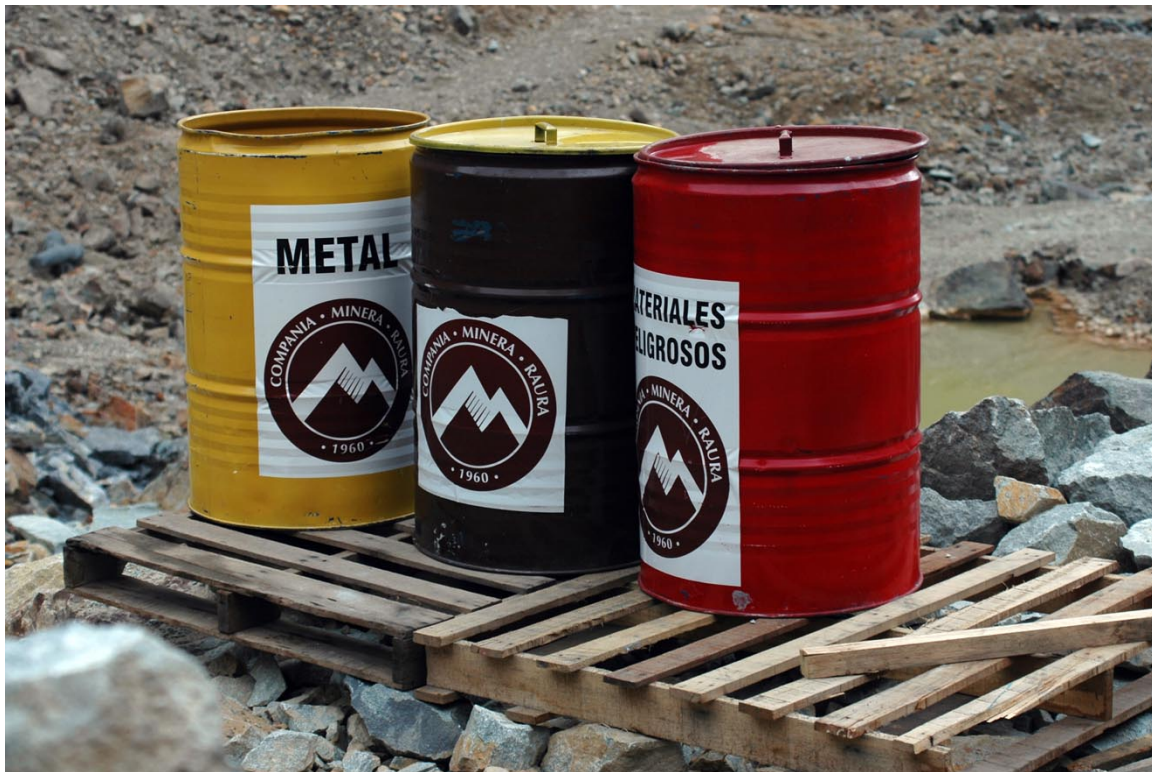
PHOTO 10: Solid waste barrels
