Raura Mining Company Perforates Glacier within the Cordillera Huayhuash Reserved Zone

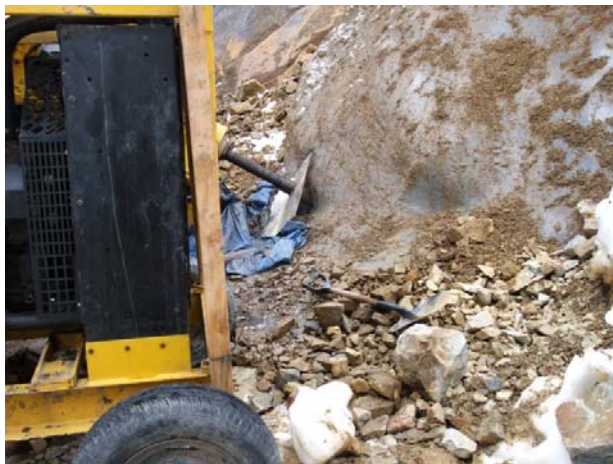
An exploration drill obviously perforating the glacier. WGS84 UTM Zone 18s 282555E 8861436N –altitud 4848. Date: March 29 2011. Photo: Marco Arenas.

In Peru the Supreme Decree 020-2008-EM, article 31, subsection 2, states that mining activity cannot be realized “on glaciers or within 100 meters of the border of a glacier” (translation mine). Clearly the mine violated this law. Additionally the Raura Mining Company is undertaking its exploration activities without the proper authorization from the National Water Authority (ANA) for the use of water. Furthermore, according to the MINAM report, the Raura Mining Company is not complying with its environmental management standards as outlined in their own Environmental Impact Statement (EIS) for the exploration project (the EIA was authorized by the Ministry of Energy and Mines through the Resolution 004-2010-MEM/AAM). These observations make it clear that CIA Minería Raura S.A., the company responsible for the Diablo Mudo Mining Project, are infringing upon laws that regulate mining activity in Peru.

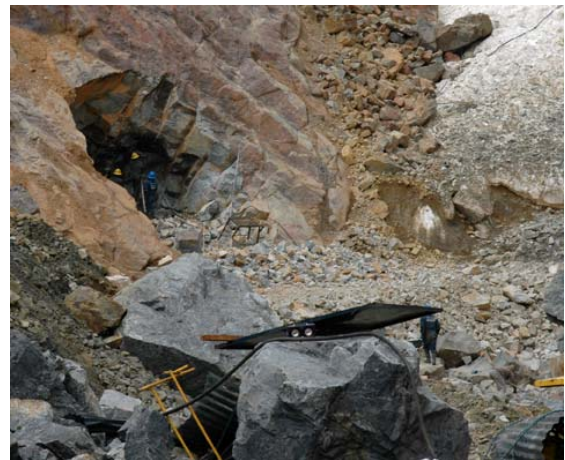
Five weeks later, the drill is no longer in the glacier (although the previous hole is visible in the ice) and the drilling is still well within 10 meters of the edge of the glacier. Date: May 9 2011. Photo: Timothy Norris.
